**OGV CLEAN FUEL REGULATION INVESTIGATION OF
OPERATIONAL ISSUES PRELIMINARY FINDINGS**

ARB CONTRACT No. 09-410

**Air Resources Board
1001 I Street
Sacramento, CA 95814
Agreement No. 09-410**

August 2011

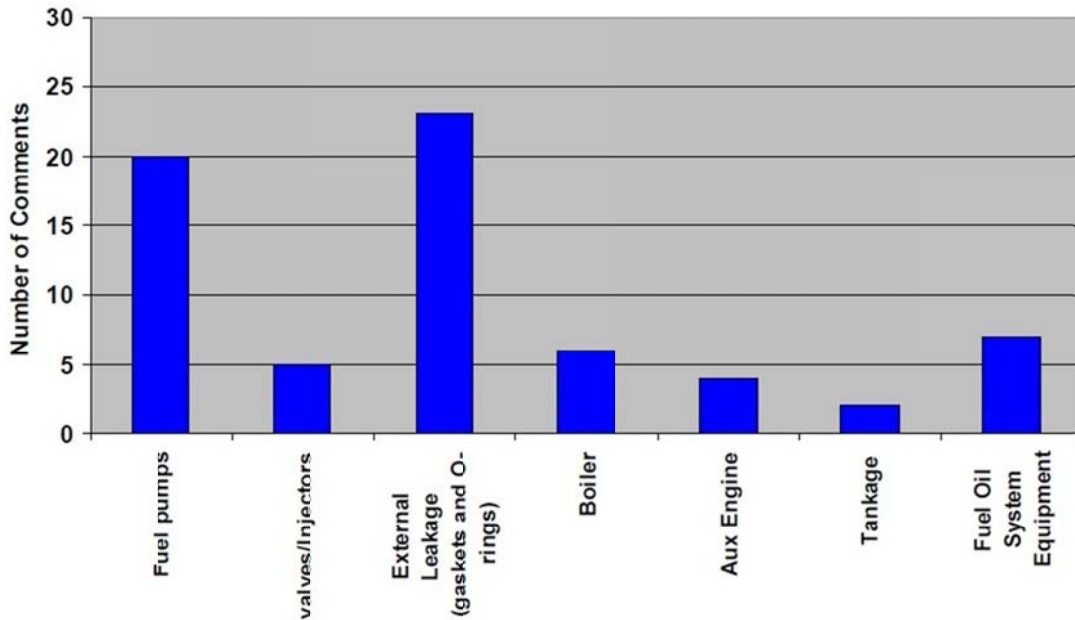
Figure 2.2-2: OGV Survey Reported Equipment Problems

The fuel switching operational problems reported in the ARB Survey were primarily noted as occurring after switching from heavy fuel oil to distillate (see Figure 2.2-2 below) and a higher number of problems were noted during maneuvering as compared to transiting. Equipment problems were noted across a variety of equipment with the highest number of problems focusing on equipment leaks and with fuel pumps as shown in Figure 2.2-2.

Excessive fuel leakage due to the low viscosity of distillate fuel can be a significant problem that can affect vessel operation (Figure 2.2-2). Excessive fuel leakage from fuel system gaskets and seals, circulating pump shaft seals, high-pressure fuel pumps, and fuel valves has been reported. Internal leakage through high-pressure fuel pumps and fuel valves can result in an excessive amount of fuel returning back to the fuel drain tank.

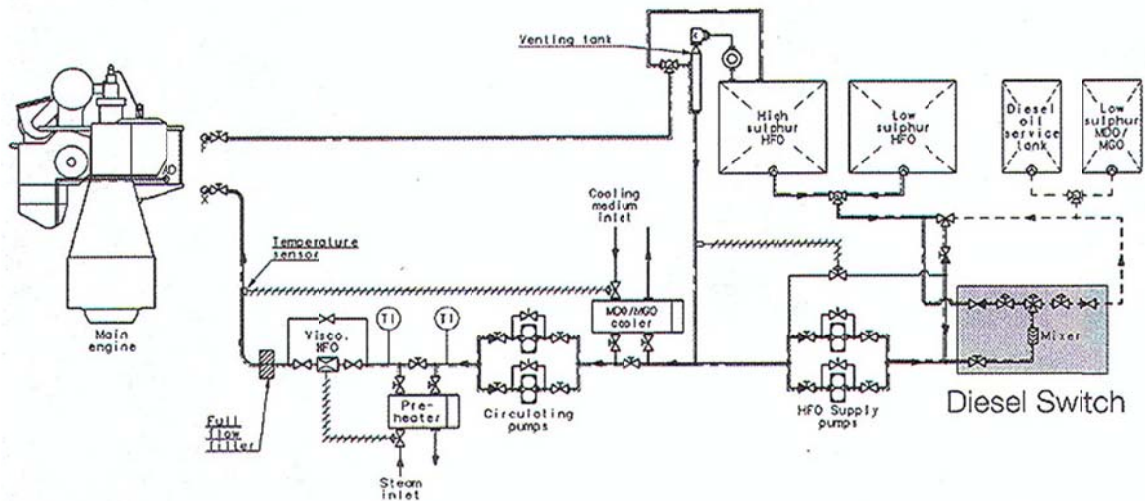
Figure 3.2-2: Modern Fuel System with A Distillate Fuel Cooler and Diesel Switch Modifications

During the switching process, a mixture of fuels with significantly different properties is circulated within the fuel system. For example, if the system was charged with distillate fuel and changing over to HFO was desired, the fuel temperature would be increased at a steady rate while HFO was slowly introduced into the fuel circulating system through a mixing valve. Throughout the process the appropriate fuel viscosity must be maintained while raising the fuel temperature at the prescribed rate. Automation is available which can simplify the switching process for the engineering crew and avoid rapid temperature deviations. One example would be the "Diesel Switch" sold by MAN B&W and is illustrated in Figure 3.2-2.

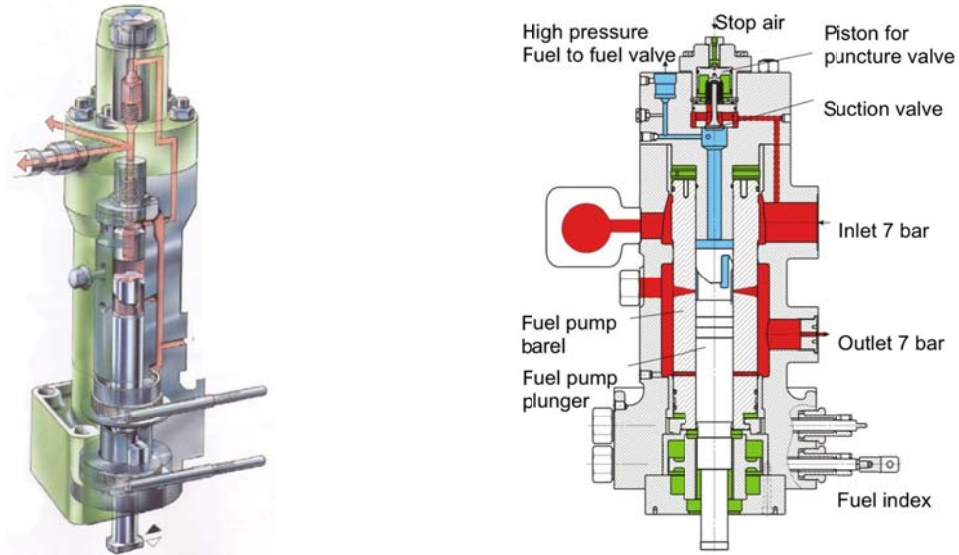
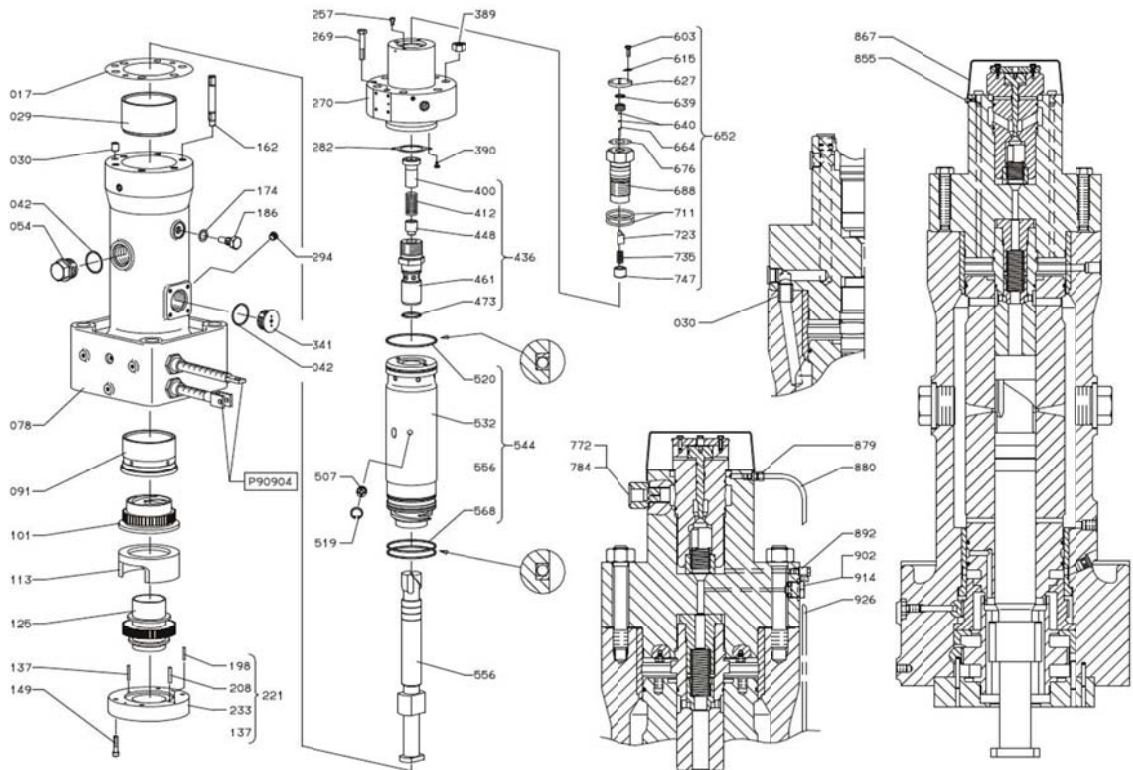
Figure 3.3-1: High Pressure Fuel Pump Overview Drawings

The high pressure fuel pump system for a typical main engine is shown schematically in Figure 3.3-1 and as an assembly drawing is shown in Figure 3.3-2. This component has been associated with issues concerning leakage past the suction valve and internal O-rings. High pressure fuel pump leakage can occur due to, 1) worn barrel and plunger (piece 556 & 532), 2) leaking puncture valve slide (piece 723) or valve housing “O-ring” seals (piece 711), or 3) Leaking suction valve slide (piece 448) or seal (piece 473.)

The barrel and plunger are manufactured to very precise tolerances to minimize fuel leakage. A small amount of leakage is required as the fuel is utilized to lubricate these moving metallic parts. Over time, as the pump plunger and barrel become worn fluid leakage will increase. Using fuel with lower viscosity will increase the leakage volume even further. If the leakage becomes excessive, it will reduce the pump discharge pressure resulting in a reduced volume of fuel going to the engine.

The suction valve slide automatically lifts off its sealing surface allowing fluid from the pump suction gallery to enter the pump barrel on the downward stroke of the pump plunger. Any leakage of the housing seals or slide will lower the developed

pressure on the upward plunger stroke and decrease fuel delivery volume. The decrease in fuel volume may decrease the fuel injection pressure.

Problems with the fuel pump have been correlated with excessive internal leakage between the high-pressure pump plunger and barrel. This problem was identified as a likely root cause for some of the LOP incidents. For fuels with lower viscosity, more leakage will occur thereby decreasing fuel injection pressures.

The fuel pump index is dependent on the amount of pump wear and the viscosity of the fuel oil. Worn fuel pumps and leaking suction valves will show up as an increased fuel index and results in lower fuel injection pressures. The manufacturer recommends overhauling the pumps when the index has increased 10% above the fuel index for a new pump.

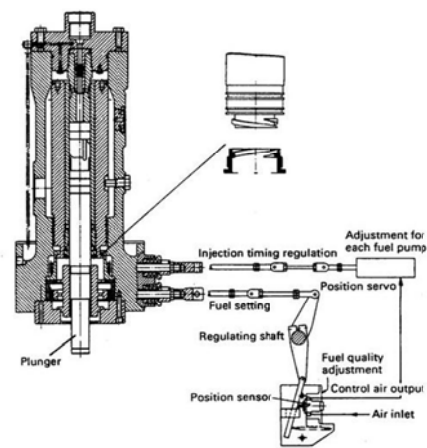
Figure 3.4-1: Super VIT System

On those engines fitted with Variable Injection Timing (VIT), the engine control system will significantly advance the injection of fuel into the cylinder to increase peak firing pressures and improve combustion during engine start-up. It is important that the VIT injection control system is working properly when operating on low-viscosity distillate fuels. The lower viscosity increases leakage past the fuel pump plunger lowering injection pressures and retarding fuel injection into the combustion chamber. A properly working VIT control will mediate this problem and improve combustion during the initial engine starting process.

The VIT system must be checked regularly to insure that the system is moving freely and is operating in the manner prescribed by the engine manufacturer.
