Landfill Methane Research Workshop: Methane Remote Sensing for Leak Identification and Mitigation

Dr. Jason Schroeder, CARB

Dec 5, 2022

Methane Technology Assessment

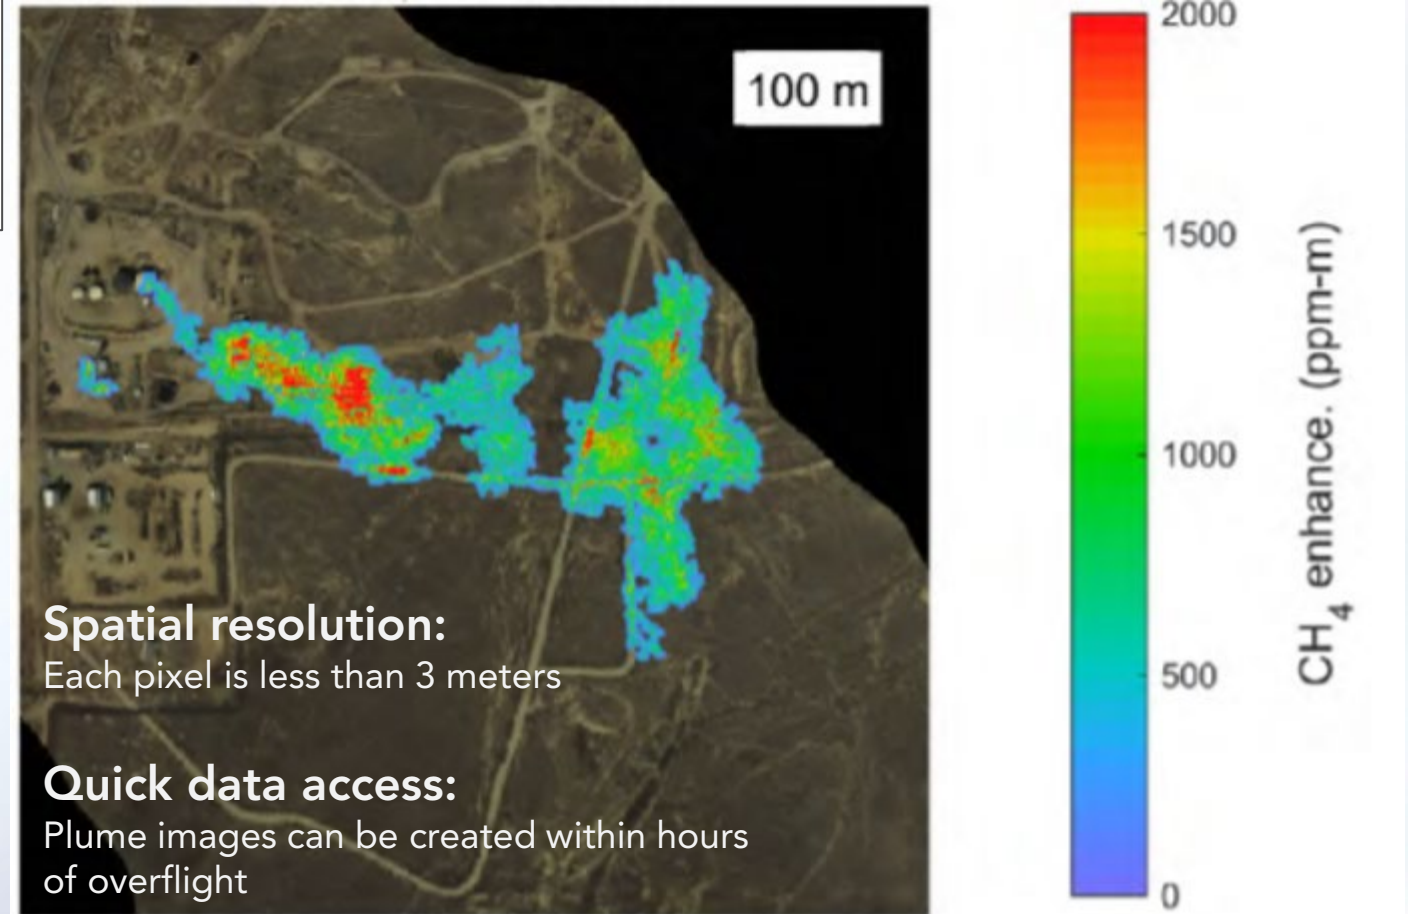
Spatial resolution:

Each pixel is less than 3 meters

Quick data access:

Plume images can be created within hours of overflight

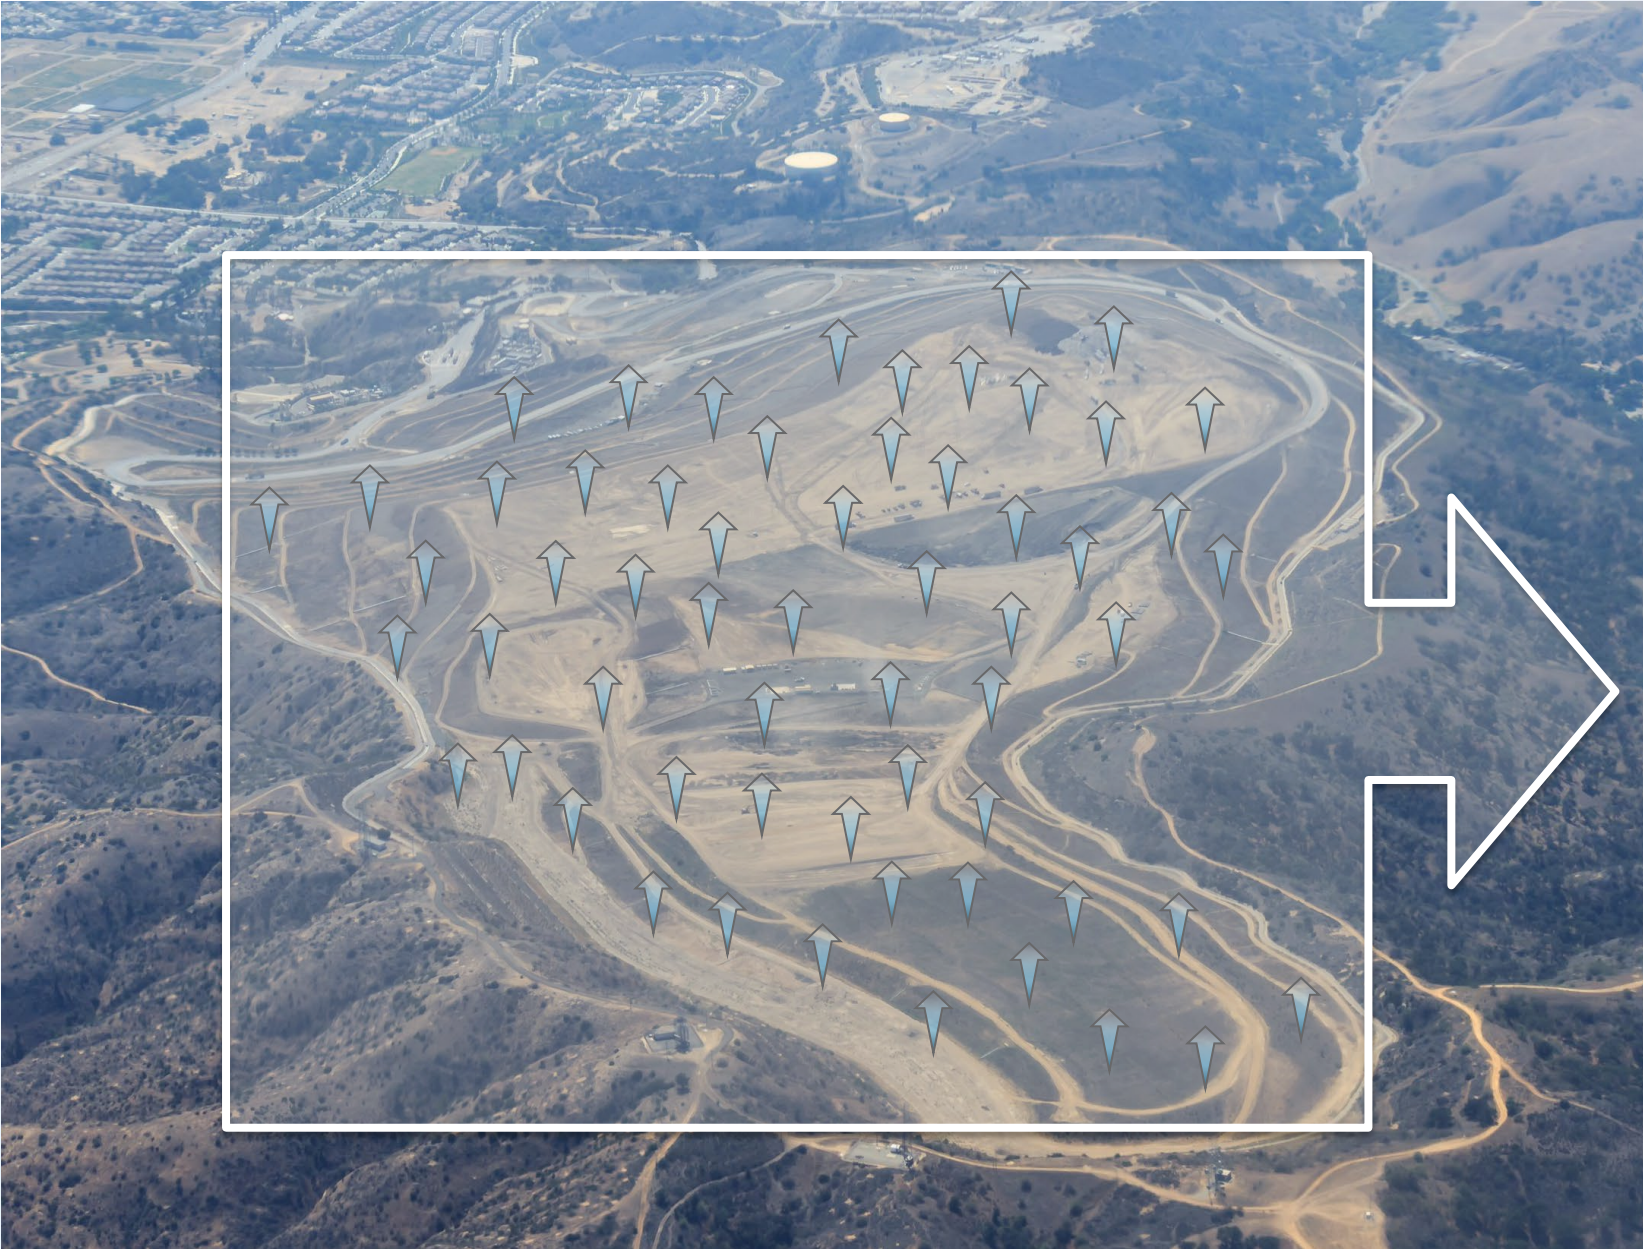
Ex: Diffuse Emissions at a Landfill

"Diffuse" or "area-wide" source:

Small sources of emissions scattered over the landfill property

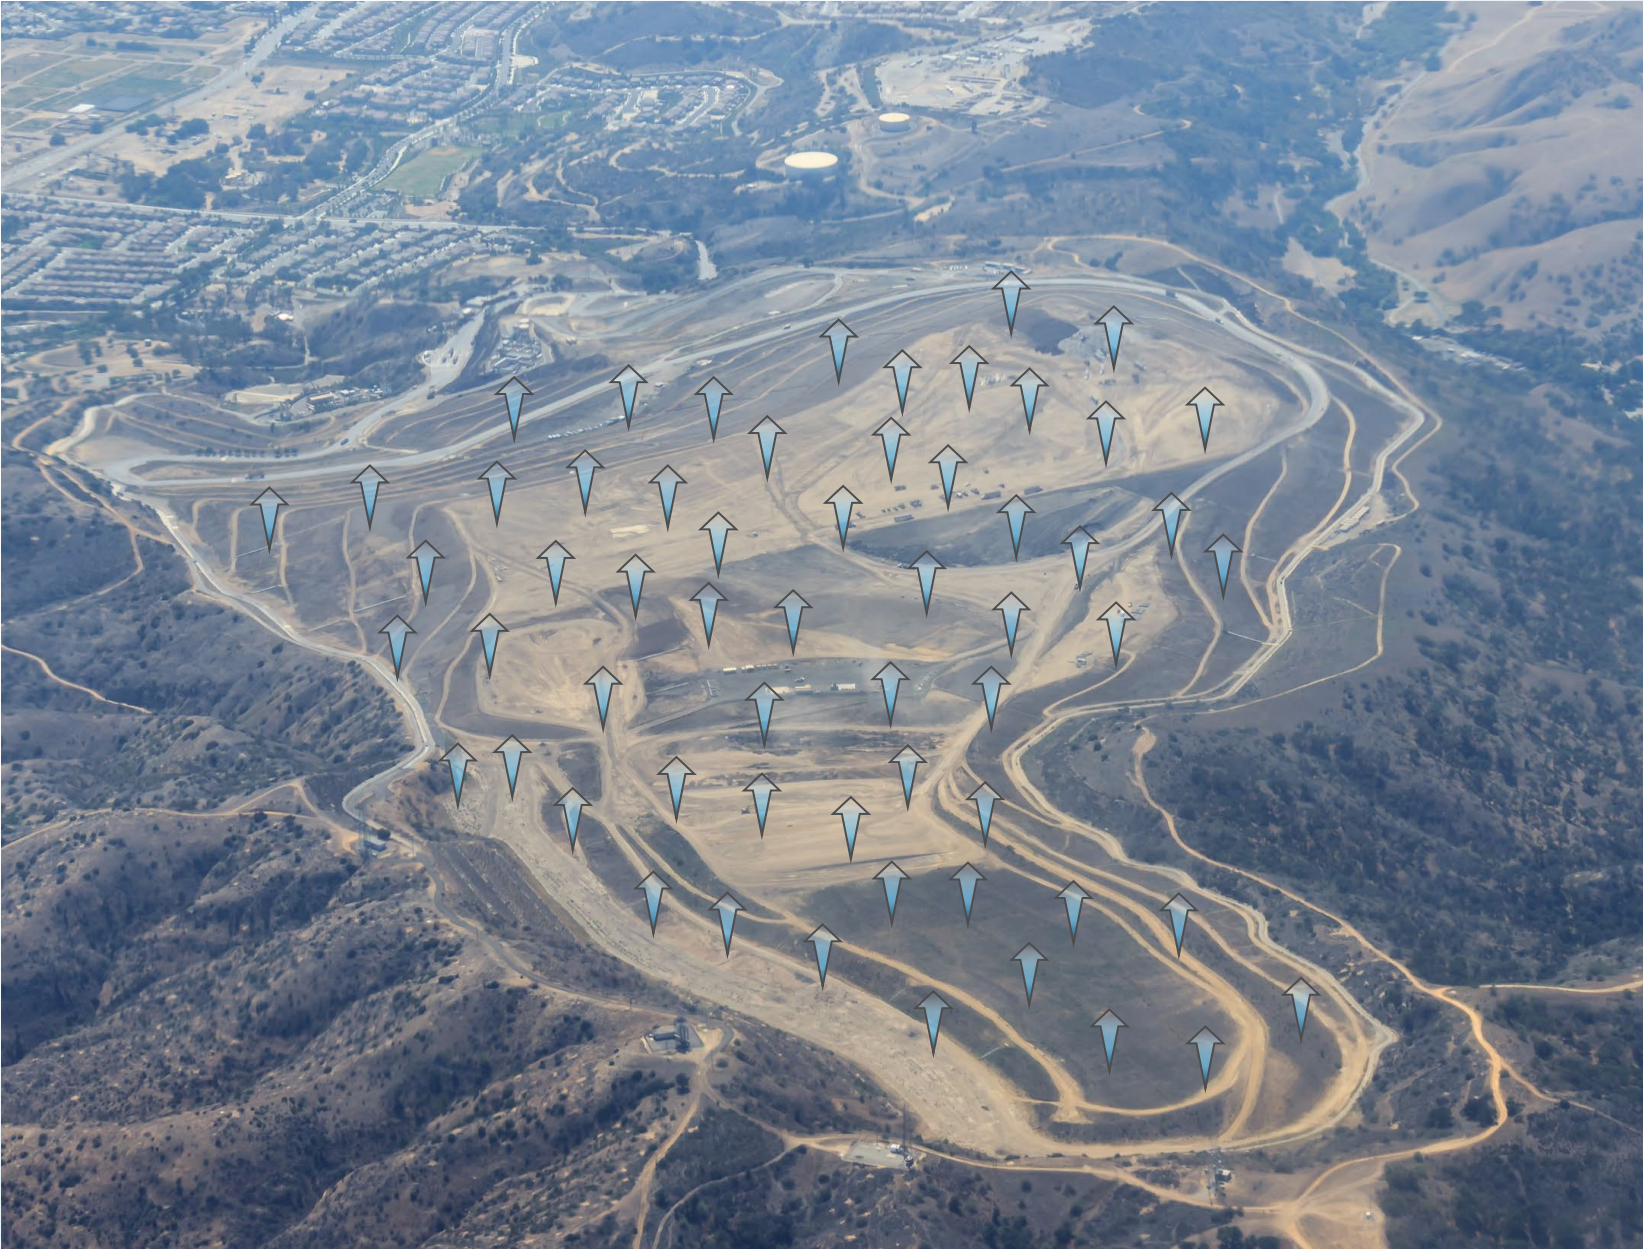
Ex: Diffuse Emissions at a Landfill

Small/diffuse sources won't be detected

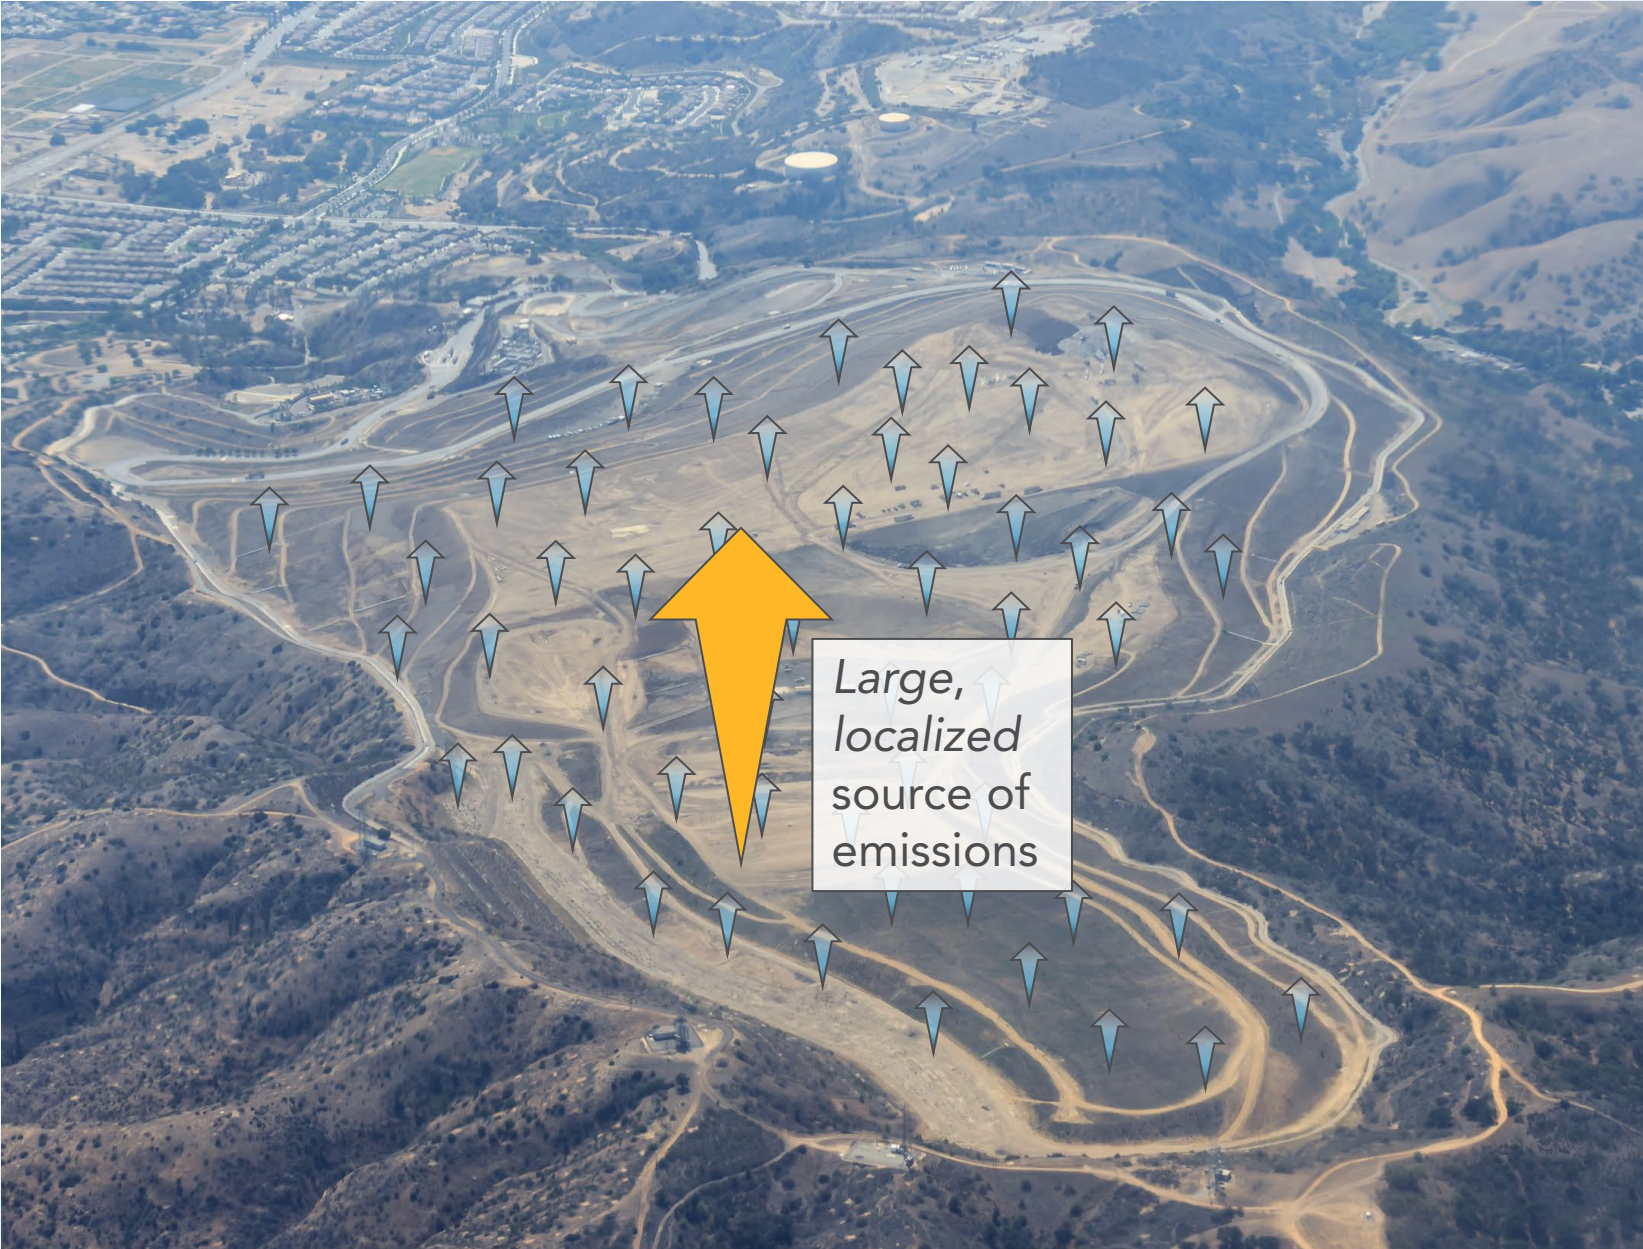
Ex: Diffuse Emissions AND a Large Plume

Large,
localized
source of
emissions

One plume
detection

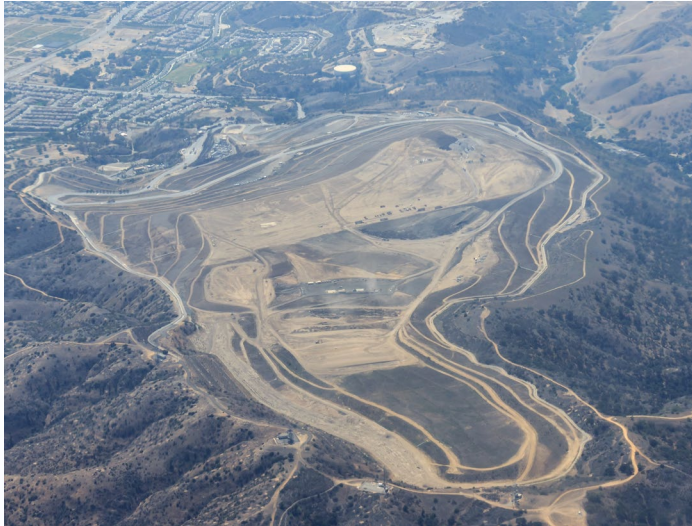
Plume Rate \neq Total Annual Emissions

— Total emissions

★ Large, localized sources

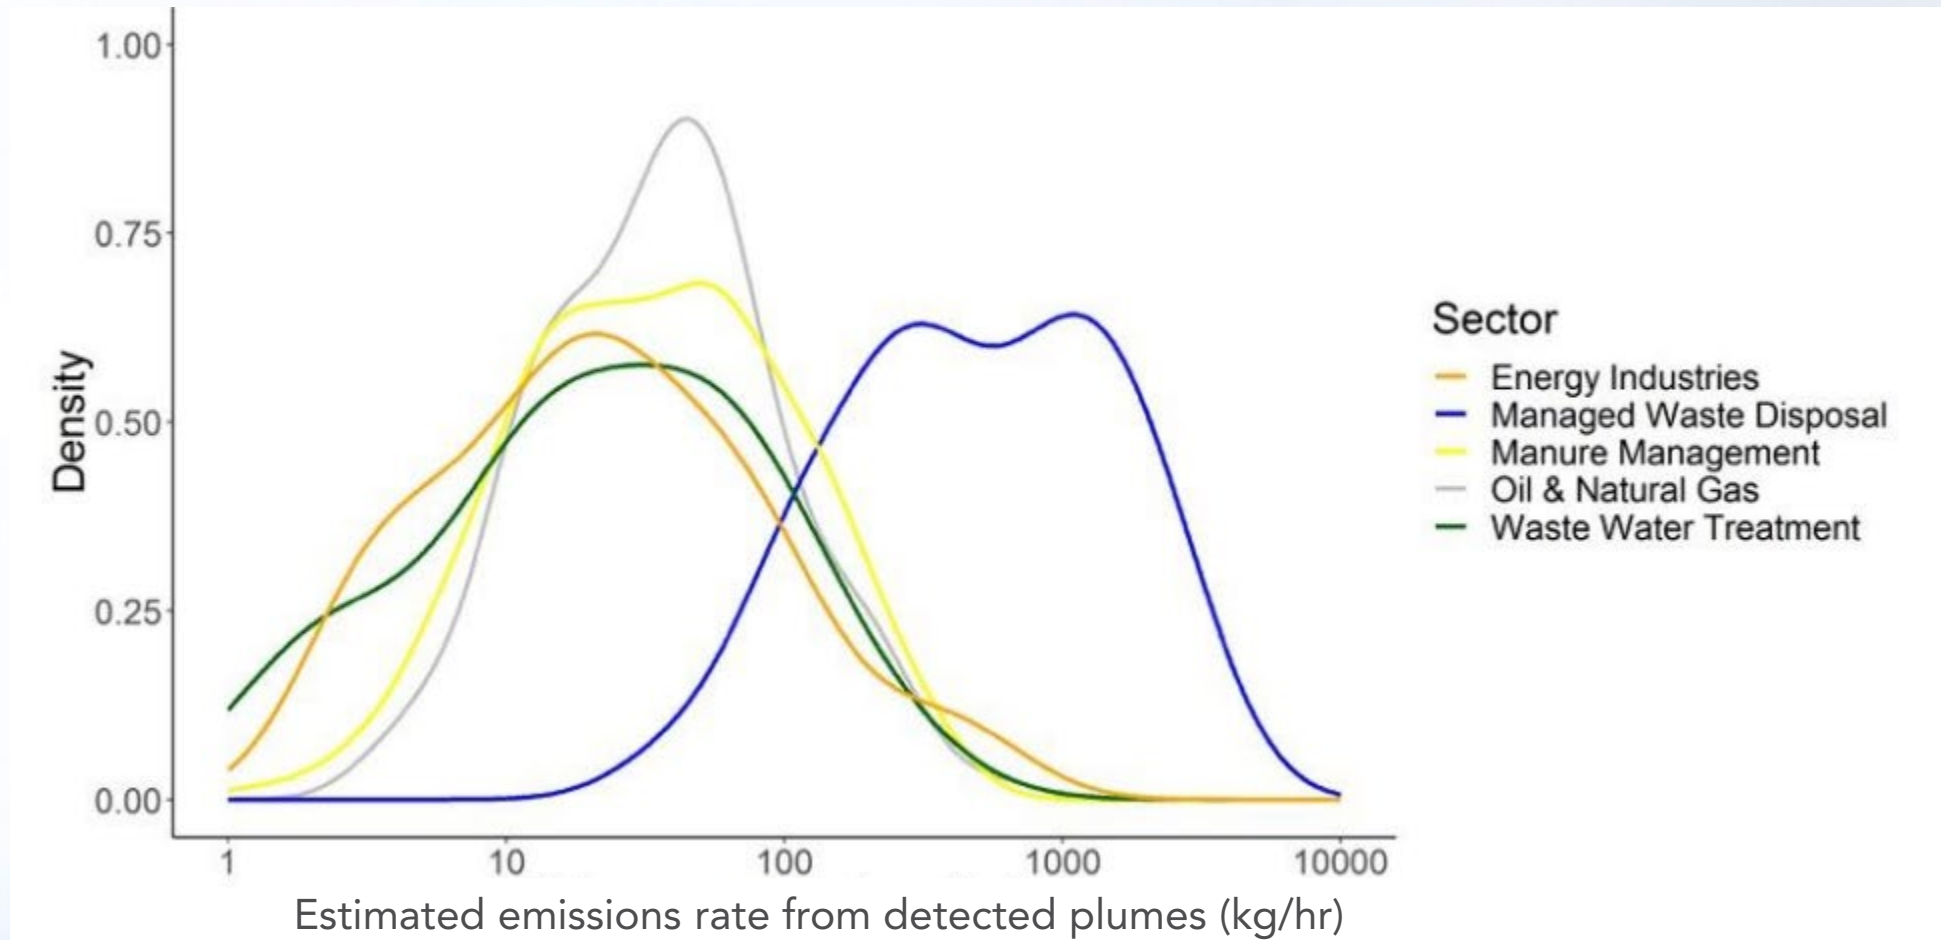
Detectable emissions from Landfills tend to be larger than other detectable emissions

Result	Key Takeaway
Methane plumes were detected at 32 out of 436 waste disposal sites	The majority of waste disposal sites emit as <i>area-wide sources</i> only and are not detectable with this technology
Detected landfill emissions rates: 41 – 3,000 kg/hr (average: 818 kg/hr)	When landfills have detectable plumes, they are large on average
For landfills with methane plume detections, detectable emissions were highly persistent BUT emission rates and spatial patterns were highly variable	Landfills that have detectable emissions once tend to have detectable emissions again but high variability means they are not representative of average conditions over a year (“snapshotty”)

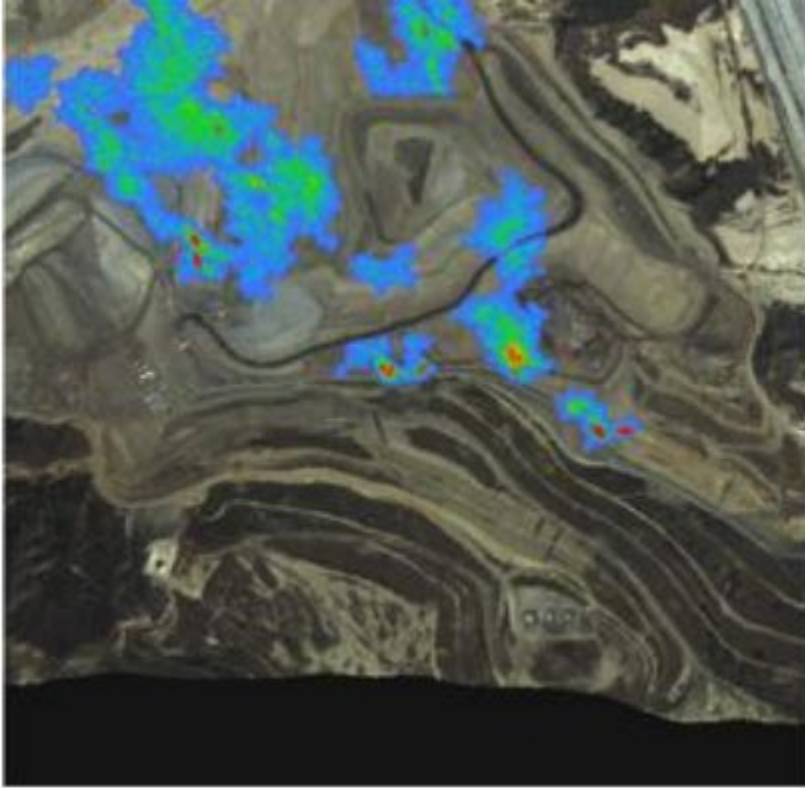
October 2016
Sum of Emissions:
~3,000 kg/hr

Example of landfill with different plume patterns and different emissions

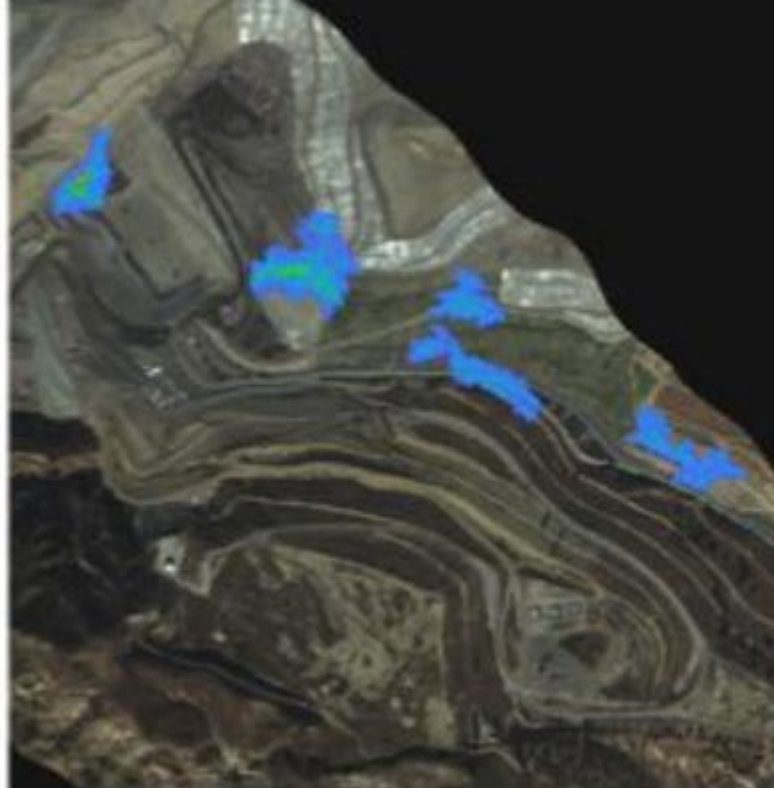
October 2017
Sum of Emissions:
~1,000 kg/hr

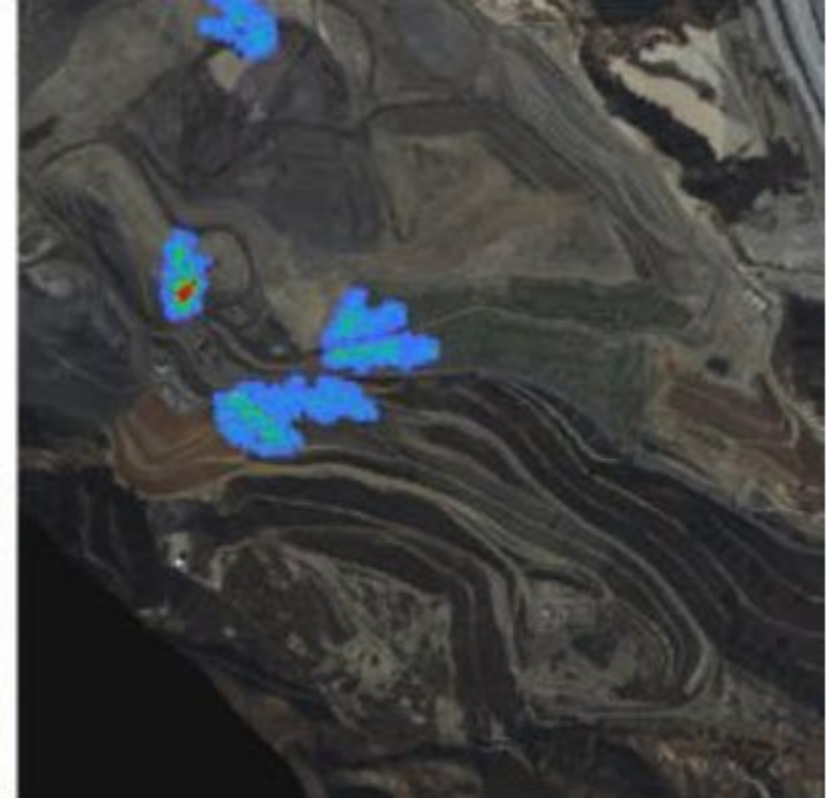
October 2018
Sum of Emissions:
~1,500 kg/hr

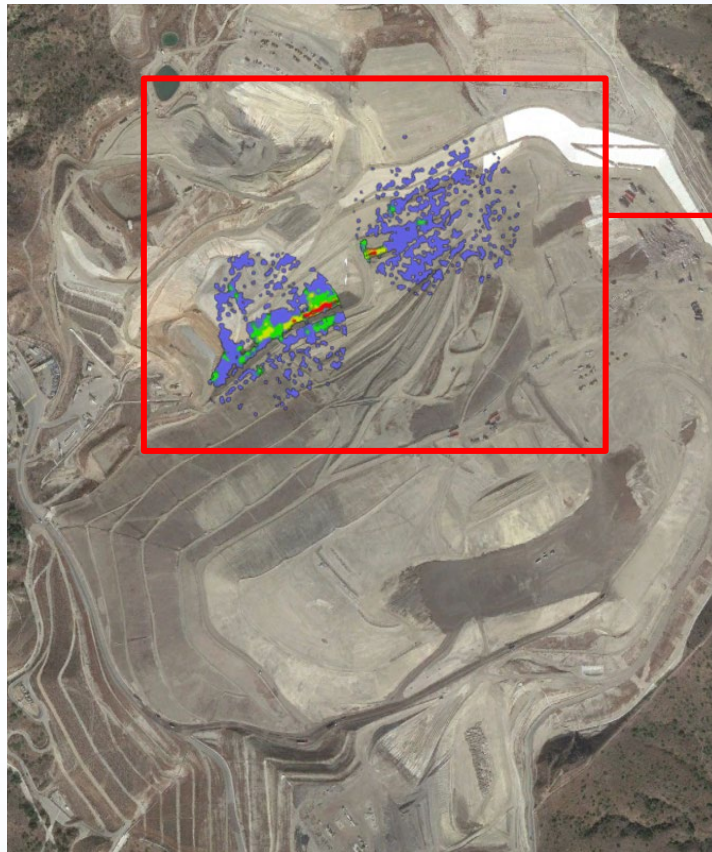
Estimated
Emission rate:
~1,000 kg/hr

Oct 23, 10:30 am
Total emissions: ~1,000 kg/hr

Example of Landfill with plumes that changed between flyovers in the same day

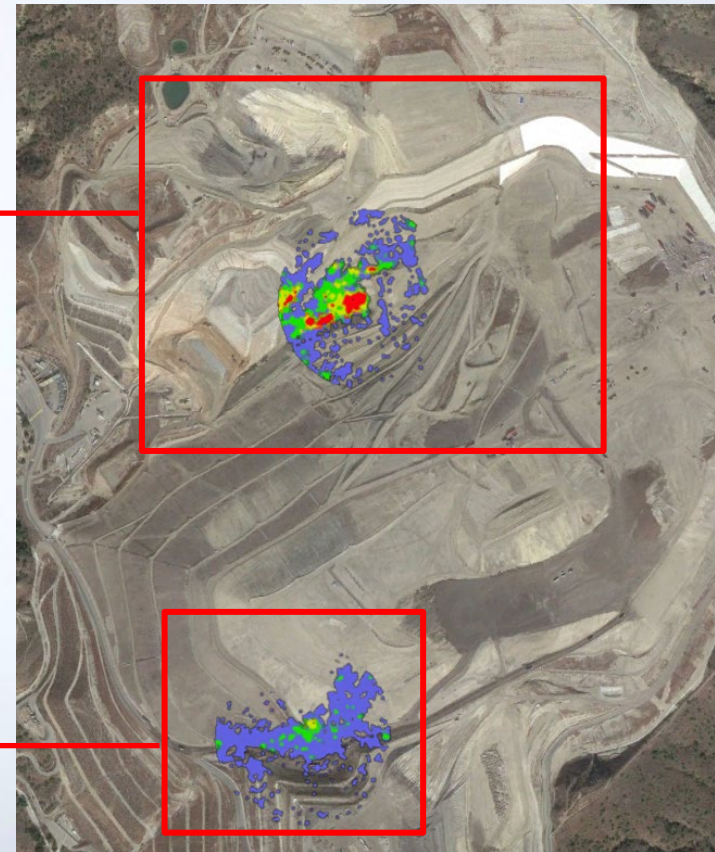
Estimated
Emission rate:
~300 kg/hr

Oct 23, 12:50 pm
Total emissions: ~1,300 kg/hr

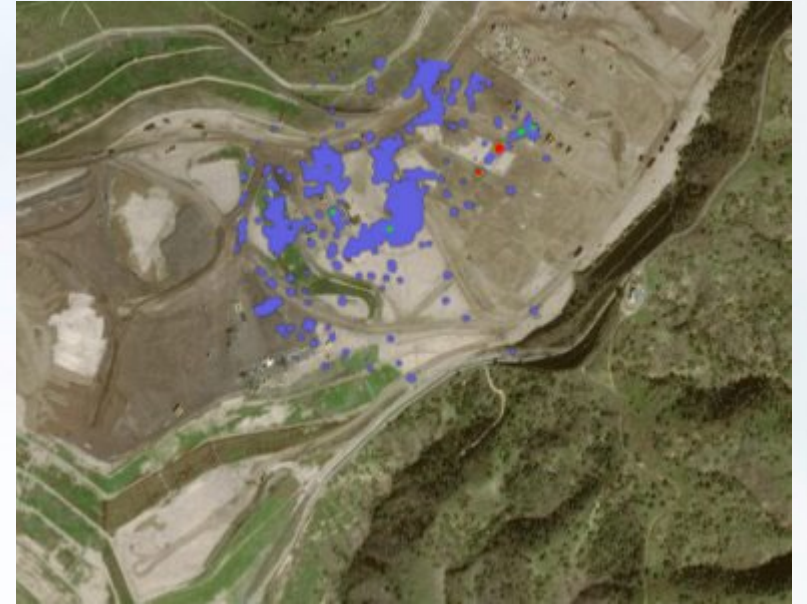
Example: Emission from Surface Cover Cracks

The leak was found to be due to surface crack emissions. Soil in the area was re-compacted on Dec 1, 2022. Methane concentrations in the area after soil re-compaction were 20 ppm.
