**OGV CLEAN FUEL REGULATION INVESTIGATION OF
OPERATIONAL ISSUES PRELIMINARY FINDINGS**

ARB CONTRACT No. 09-410

**Air Resources Board
1001 I Street
Sacramento, CA 95814
Agreement No. 09-410**

August 2011

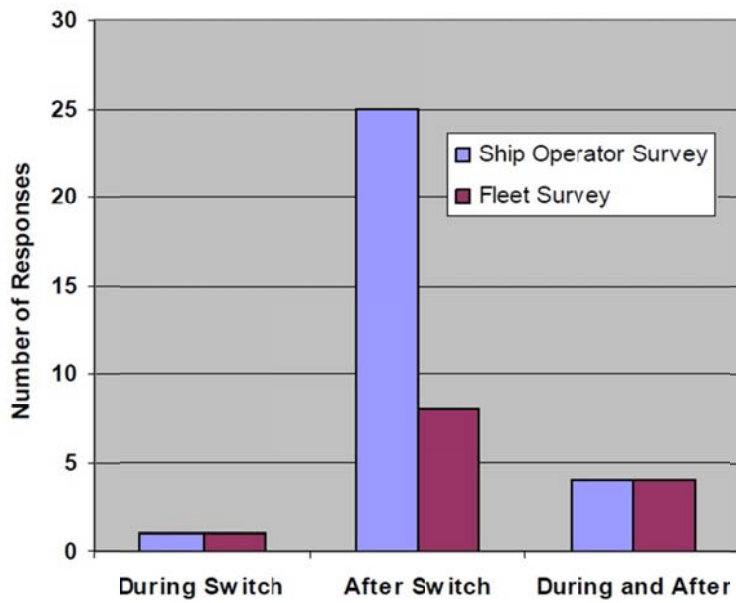
Figure 2.2-3: OGV Survey Timing of Problems Due to Fuel Switching

Figure 2.2-3 illustrates the responses to an OGV Survey question “If you had problems, did the problems occur during fuel switching, after fuel switching or both?” Vessel operators reported that more difficulties occurred after fuel switching than the time period during which the fuel switching was taking place.

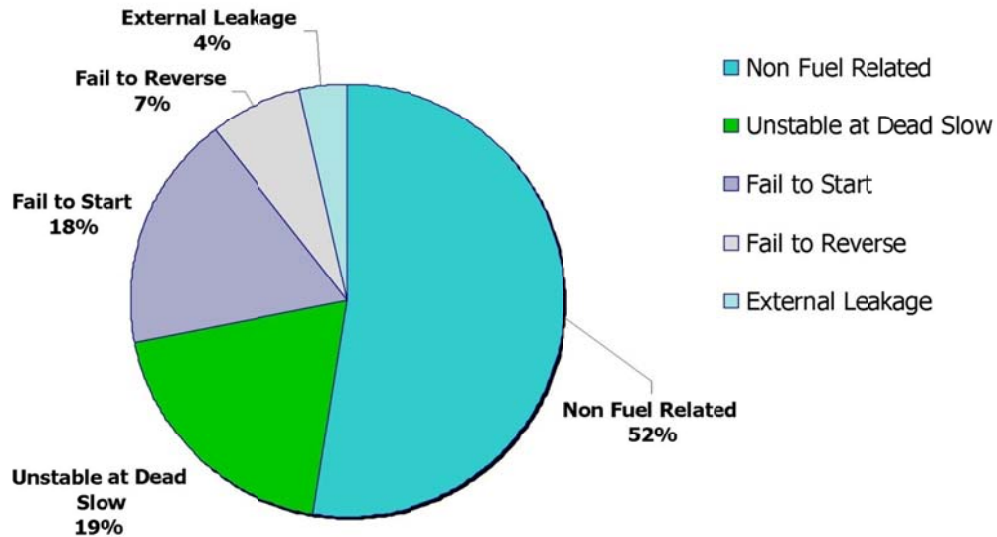
Figure 2.3-2: Breakdown of LOP Incidents.

CMA Technical Staff reviewed the LOP incident reports that were denoted by the USCG as being fuel switching related and identified the primary operational issue that resulted in the LOP. As shown in Figure 2.3-2, the primary operational issues noted were: the main propulsion engine was unstable at low loads, the main engine failed to start, excessive fuel leakage, and failure to reverse. It is the opinion of CMA Technical Staff that the LOP incidents are primarily related to: 1) fuel viscosity management, 2) maintenance procedures, 3) crew training, and 4) fuel system equipment condition. Below, CMA Technical Staff discuss the four operational issues most commonly reported in the LOP Fuel Switching Related reports reviewed as part of this investigation.

FAIL TO START

The main engine will not start on distillate fuel. In many cases, this was preceded by unstable operation at Dead Slow. The specific cause in each case varied but included excessively worn high-pressure fuel pump plunger/barrel wear, misadjusted or inoperative variable injection timing, low pressure within the fuel system, sticking high-pressure pump suction valve push rods, and excessively low fuel viscosity.

FAIL TO REVERSE

The main engine can run at low loads and will start normally; however, it cannot start when the engine attempts to reverse while the vessel is proceeding through the water above a certain speed. In that condition, there can be considerable negative torque created by the propeller “wind milling”. An engine that can start in the ahead direction may have trouble in this scenario due to the extra load imposed by the “wind milling” effect of the propeller.

EXTERNAL LEAKAGE

There are leaking O-rings on fuel valves (fuel injectors) causing excessive fuel leakage and leakage on high-pressure manifold. Loss of propulsion was due to a voluntary shut-down of the main engine to repair leakage before vessel proceeded to its destination.

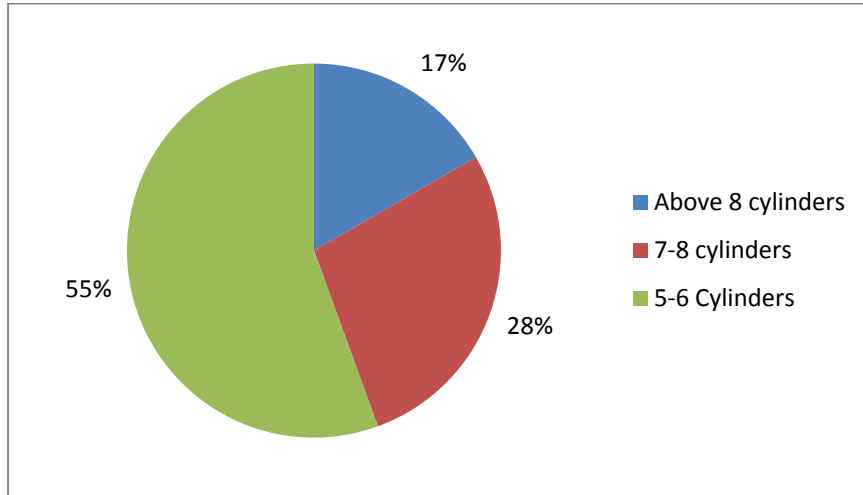
Figure 2.3-6: Fuel Switching Related LOPs Referenced by Number of Engine Cylinders

The fact that engines with fewer than seven cylinders have the largest percentage of fuel switching related LOP's as shown in Figure 2.3-6 may be more than purely statistical. The more cylinders that an engine has the less it would be affected by poor combustion in one of those cylinders.

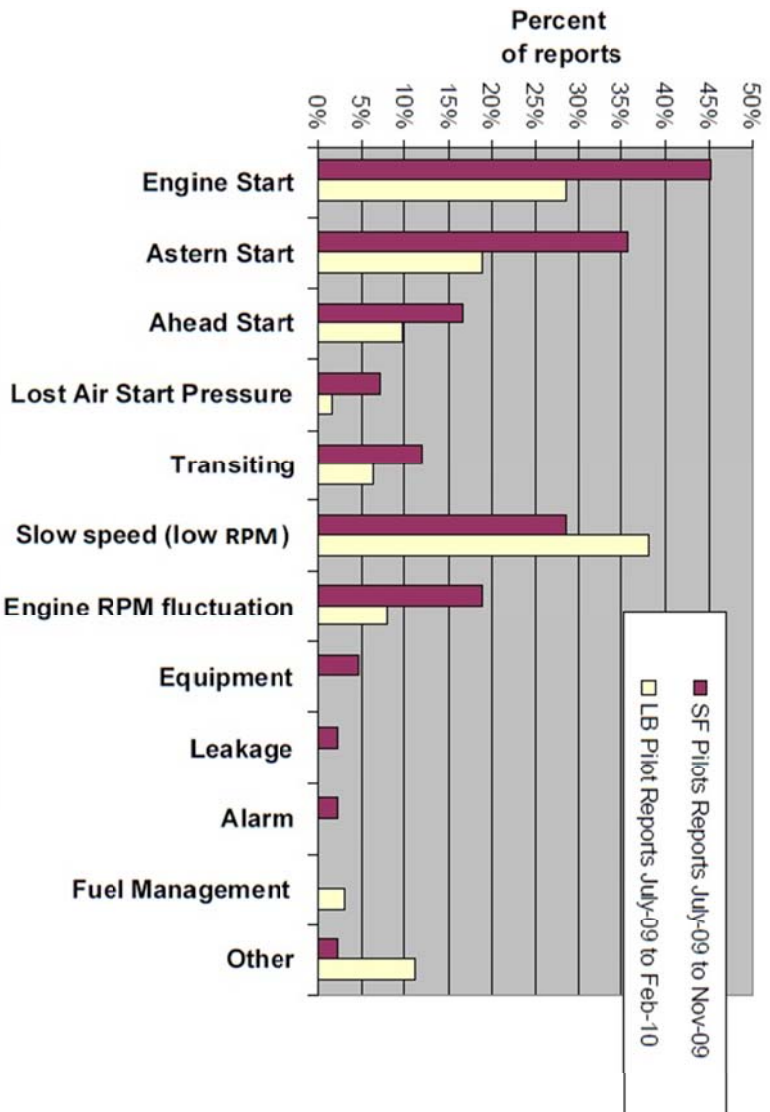
Figure 2.4-1: Breakdown of OGV Incidents Reported by SF Bar & LB Pilots

From July 2009 through December 2009, the San Francisco Bar Pilots and the Long Beach Bar Pilots maintained logs of any operational issues that they noted while piloting a vessel. The types of operational issues were grouped into 12 categories as shown in Figure 2.4-1 below. The operational problems reported show similar patterns to the USCG LOP incident reports. However, problems noted in the pilot logs did not always lead to an LOP incident.

As is shown, the vast majority of the operational incidents reported instability of the engine at low RPM (Dead Slow) or failure to start while running on distillate fuel. In addition, some vessels have reported difficulty starting the main engine in the astern direction while the vessel is moving through the water above a certain speed. The CMA Technical Staff believes the root cause for all three of these problems was poor combustion at low loads caused by low injection pressures and/or improper injection timing.
